**Flood Control Project Maintenance
Levee Inspections**

Fall 2012 Levee Maintenance Deficiency Summary Report

Reclamation District No. 0341 Sherman Island

Levee Inspection Report By Mile - Fall 2012

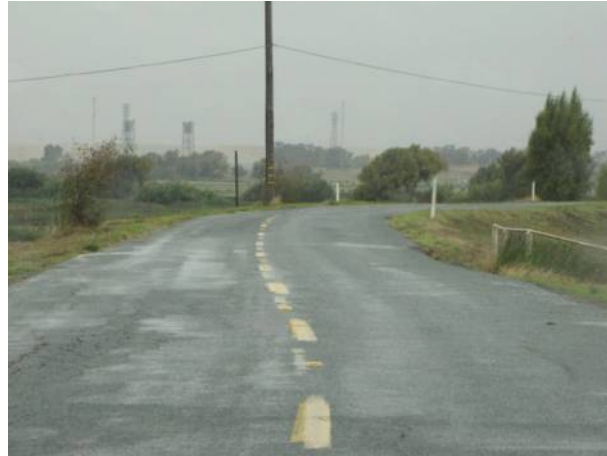
Levee Mile Report Line	4
Start Levee Mile	0.00
End Levee Mile	0.00
Location	
Category	Earthen Levee
Item	Vegetation
RD 341 looking downstream from levee mile 0.00. Photo taken 11-08-2012.	
phillips_f_20121119_383.jpg

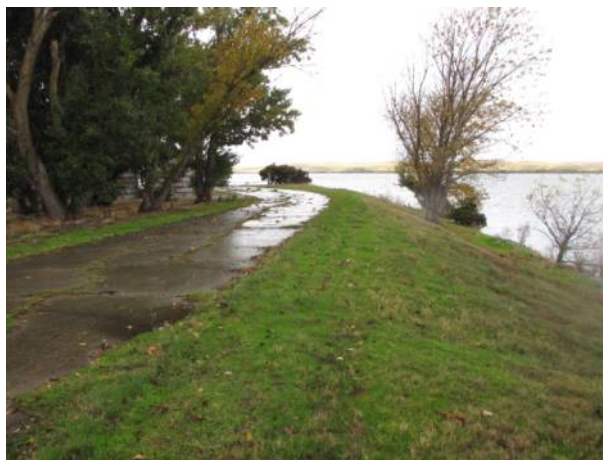
Levee Mile Report Line	1
Start Levee Mile	3.45
End Levee Mile	3.45
Location	Land Side
Category	Earthen Levee
Item	Vegetation

LMR No.	Levee Mile		Category	Item	Location	Rating	Action/Comment	GPS Latitude/Longitude		Issue No.
	Start	End						Start	End	
1	3.45	3.45	Earthen Levee	Vegetation	LS	A Ob	V1 : Control annual grass and weeds on the levee slopes and easements. Inspector Comments: The levee slopes are mowed and the District has done a great job maintaining the levee sections.	38.104668 ° -121.704349 °	38.104668 ° -121.704349 °	12 Y
DWR ID: DWR_RD0341_02_s_2012_12										
2	4.15	4.19	Supplemental	USACE Erosion Survey	WS	M Ma	Inspector Comments: 2011 - Large new erosion pocket probably hidden by vegetation in the past. 2012: No observed change. [2012 Site ID: SAC_8-2_L]	38.095148 ° -121.706367 °	38.094590 ° -121.706393 °	4 Y
DWR ID:										
3	4.46	5.04	Earthen Levee	Vegetation	WS	M Ma	V2 : Remove the wild growth other than native grasses from the levee slopes.	38.090363 ° -121.706227 °	38.083138 ° -121.711478 °	1 Y

RD 341 Unit 2 waterside looking downstream levee mile 3.47. Photo taken 11-08-2012.

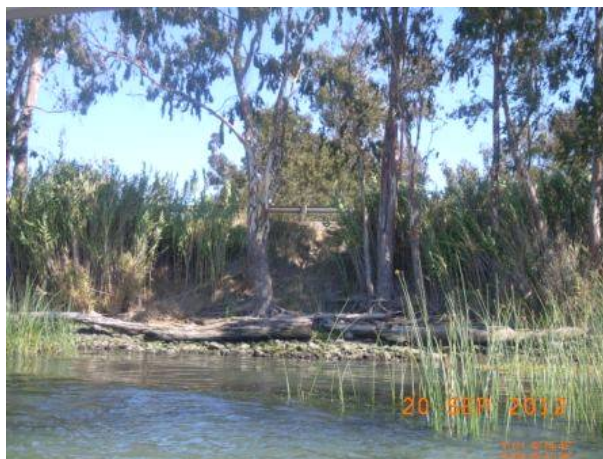
Levee Mile Report Line	2
Start Levee Mile	4.15
End Levee Mile	4.19
Location	Water Side
Category	Supplemental
Item	USACE Erosion Survey

USACE 2012 Photo #1

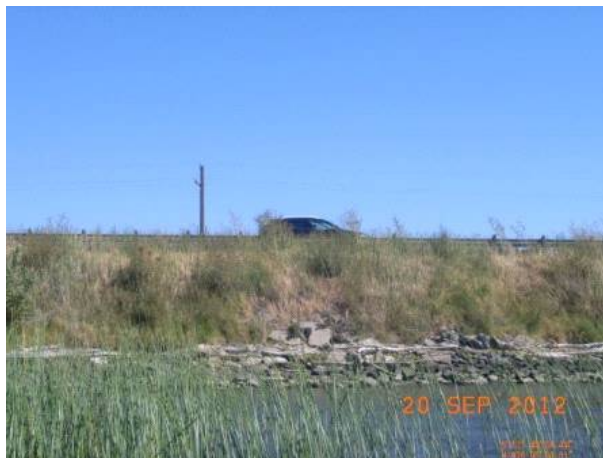
Levee Mile Report Line	4
Start Levee Mile	4.52
End Levee Mile	4.60
Location	Water Side
Category	Supplemental
Item	USACE Erosion Survey

DWR ID: DWR_RD0341_02_f_2012_1										
4	4.52	4.60	Supplemental	USACE Erosion Survey	WS	U Ma	Inspector Comments: 1999 - New small slump in eroded bank. 2005 - Reach extended because of vertical bank along the roadway upstream. 2011 - More slumping since last year. 2012: Site upgraded to critical. Very steep slope which may be effecting the highway on top of the levee. [2012 Site ID: SAC_8-0_L]	38.090620 ° -121.706684 °	38.088572 ° -121.707127 °	5 Y
DWR ID:										
5	4.73	4.81	Supplemental	USACE Erosion Survey	WS	U Ma	Inspector Comments: 2011 - Large slump section 2012: Site extended downstream, upgrade to critical, severe windwave. Slope is very steep and may be effecting the highway on top of the levee. [2012 Site ID: SAC_7-9_L]	38.086603 ° -121.707786 °	38.085459 ° -121.708607 °	7 Y
DWR ID:										
6	5.25	5.86	Earthen Levee	Vegetation	WS	M Ma	V2 : Remove the wild growth other than native grasses from the levee slopes.	38.082194 ° -121.715246 °	38.080228 ° -121.726459 °	2 Y

USACE 2012 Photo #1

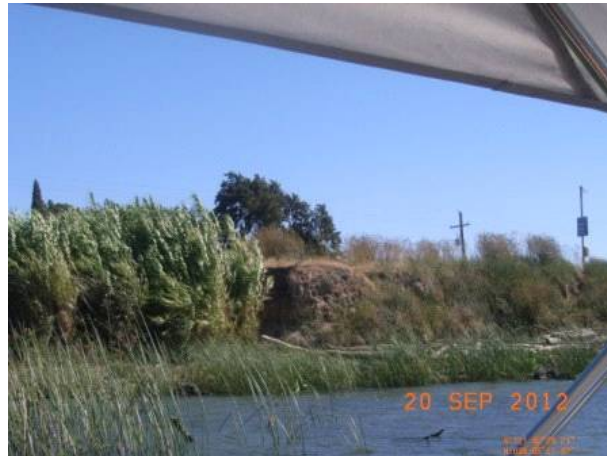
Levee Mile Report Line	4
Start Levee Mile	4.52
End Levee Mile	4.60
Location	Water Side
Category	Supplemental
Item	USACE Erosion Survey

USACE 2012 Photo #2

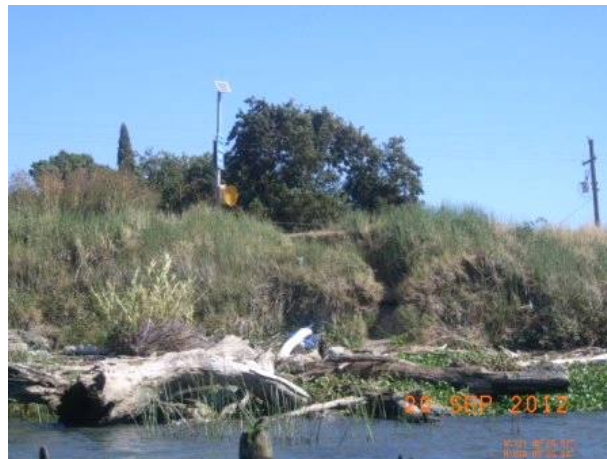
Levee Mile Report Line	4
Start Levee Mile	4.52
End Levee Mile	4.60
Location	Water Side
Category	Supplemental
Item	USACE Erosion Survey

USACE 2012 Photo #3

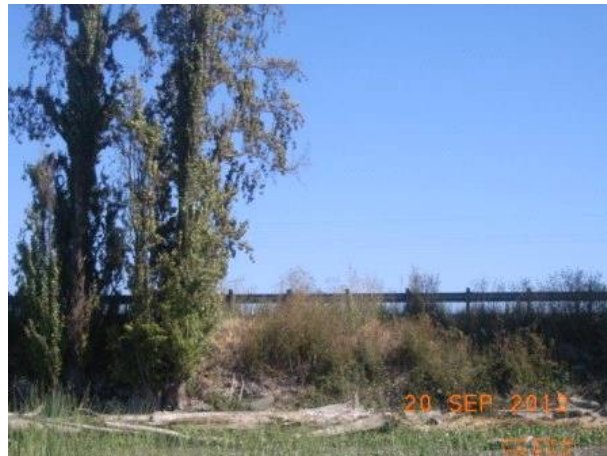
Levee Mile Report Line	4
Start Levee Mile	4.52
End Levee Mile	4.60
Location	Water Side
Category	Supplemental
Item	USACE Erosion Survey

USACE 2012 Photo #4

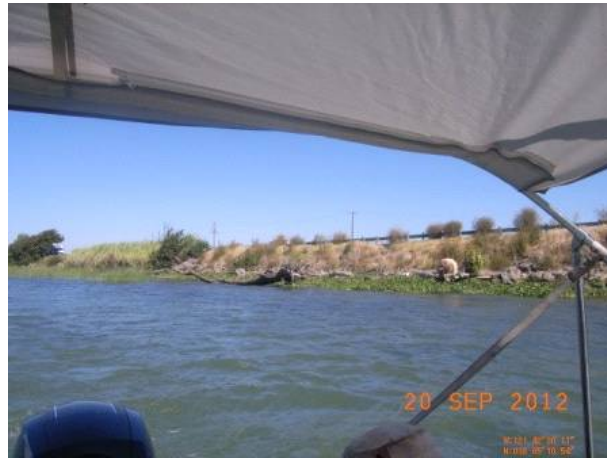
Levee Mile Report Line	5
Start Levee Mile	4.73
End Levee Mile	4.81
Location	Water Side
Category	Supplemental
Item	USACE Erosion Survey

USACE 2012 Photo #1

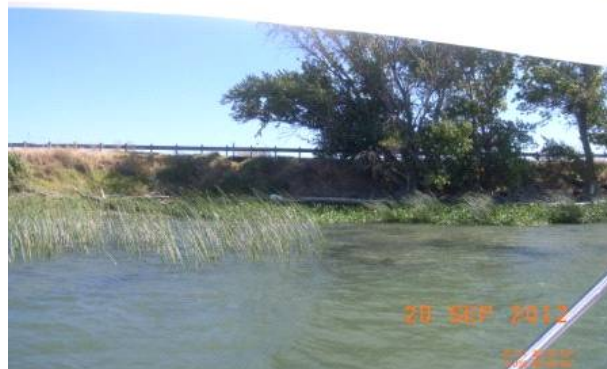
Levee Mile Report Line	5
Start Levee Mile	4.73
End Levee Mile	4.81
Location	Water Side
Category	Supplemental
Item	USACE Erosion Survey

USACE 2012 Photo #2

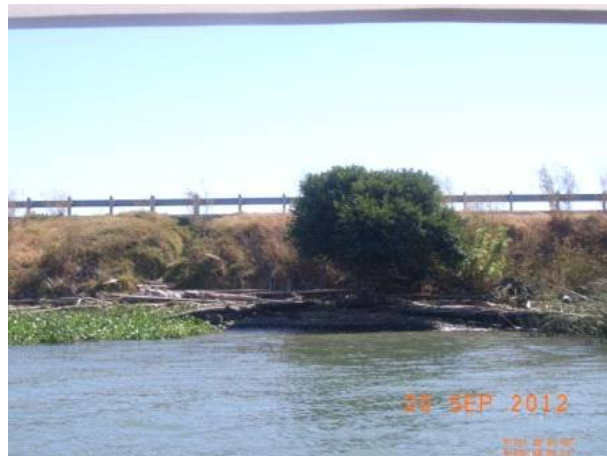
Levee Mile Report Line	8
Start Levee Mile	5.96
End Levee Mile	6.09
Location	Water Side
Category	Supplemental
Item	USACE Erosion Survey

DWR ID: DWR_RD0341_02_f_2012_2										
7	5.49	5.81	Earthen Levee	Trim / Thin Trees	LS	C Ma	T1 : Trim trees to at least five feet above ground level.	38.081252 ° -121.719488 °	38.080513 ° -121.725628 °	10 Y
DWR ID: DWR_RD0341_02_s_2012_10										
8	5.96	6.09	Supplemental	USACE Erosion Survey	WS	U Ma	Inspector Comments: 2011 - Large slump at downstream end. Gully formed from surface runoff from the road. Shallow slumping throughout site. 2012: The gully at upstream end has increased in size and site continues to worsen. [2012 Site ID: SAC_7-3_L]	38.080370 ° -121.728341 °	38.080526 ° -121.730483 °	8 Y
DWR ID:										
9	6.21	6.35	Earthen Levee	Trim / Thin Trees	LS	C Ma	T3 : Trim and thin trees to allow visibility of the ground and room to flood fight.	38.080723 ° -121.731799 °	38.081545 ° -121.735244 °	11 Y
DWR ID: DWR_RD0341_02_s_2012_11										
10	6.32	7.00	Earthen Levee	Vegetation	WS	M Ma	V2 : Remove the wild growth other than native grasses from the levee slopes.	38.082266 ° -121.730401 °	38.078770 ° -121.744280 °	3 Y

USACE 2012 Photo #1

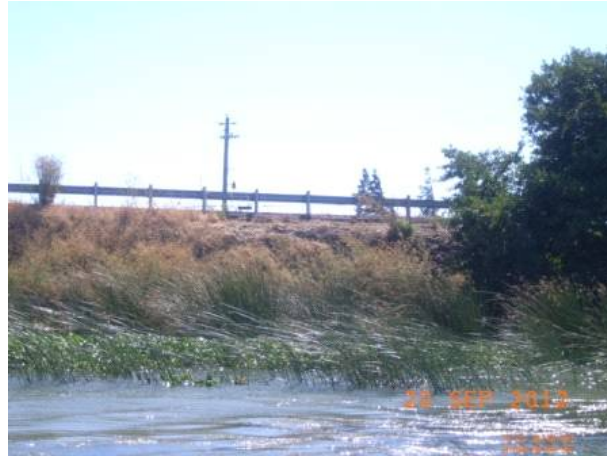
Levee Mile Report Line	8
Start Levee Mile	5.96
End Levee Mile	6.09
Location	Water Side
Category	Supplemental
Item	USACE Erosion Survey
USACE 2012 Photo #2	
USACE2012_SAC_7-3_L_2.jpg
